# PERFORMANCE TEST REPORT

# PRL ALUMINUM PR CW600/PR CW700 ALUMINUM CURTAIN WALL 8.0 psf

# **CCLW JOB #11-5484-1**

MAY 9, 2011

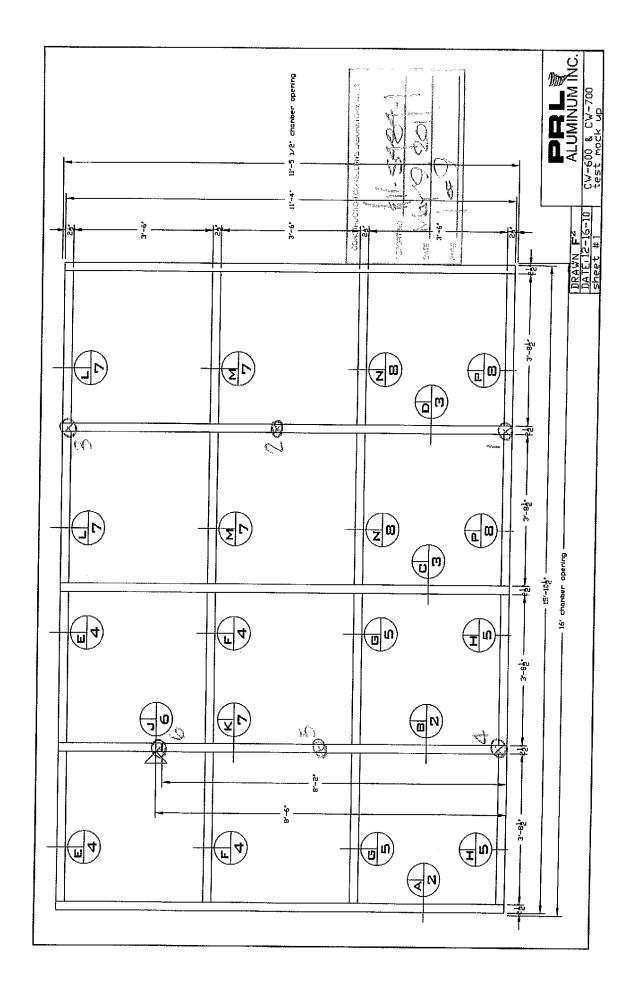
For a complete description including anchorage, glass and framing details, see drawings (sheets 1 through 9) at the conclusion of this report. Drawings are furnished by PRL Aluminum.

All measured spans complied with specified criteria. See elevation drawing, sheet 1 of 9, for dial indicator locations. See Charts #1 and #2 on page 6 for deflection and permanent set results (reference bold number - xx/xx for deflection). There was no glass breakage.

All measured spans complied with specified criteria. See elevation drawings, sheet 1 of 9, for dial indicator locations. See Charts #3 and #4 on page 7 for deflection and permanent set results (reference bold number - xx/xx for **permanent set**). There was no glass breakage.
