ASTM E 1886 and ASTM E 1996 TEST REPORT

Report No.: D1090.02-301-44

PRL ALUMINUM ARCHITECTURAL PRODUCTS
City of Industry, California

PRODUCT TYPE: Bi-Fold Door
SERIES/MODEL: Accordion Bi-Fold

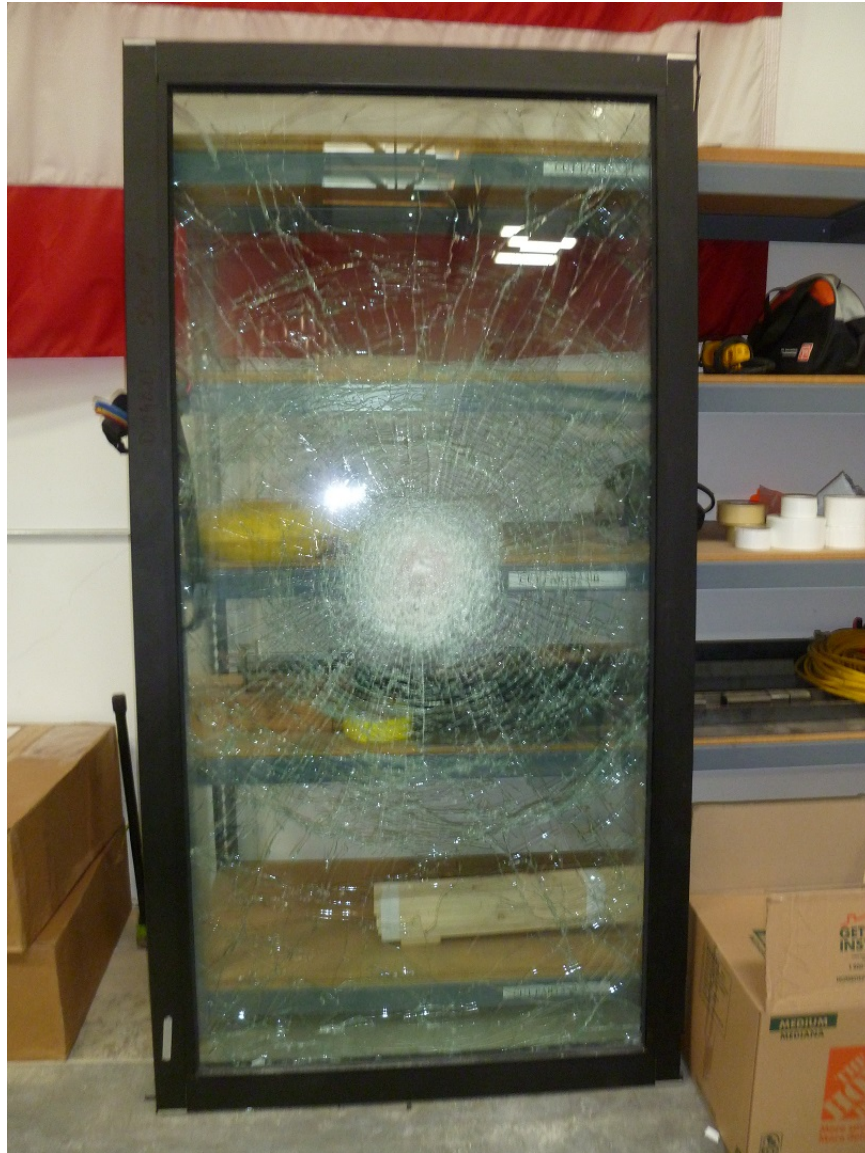
Photo No. 1
Impact Specimen #1

Impact #1: Missile Velocity: 15.2 m/s (49.9 fps)	
Impact Area:	Center of panel without hinge at jamb
Observations:	Missile hit target area, 1-1/8" tear at point of impact.
Results:	Pass

Note: See Architectural Testing Photo #1-3 for impact locations.

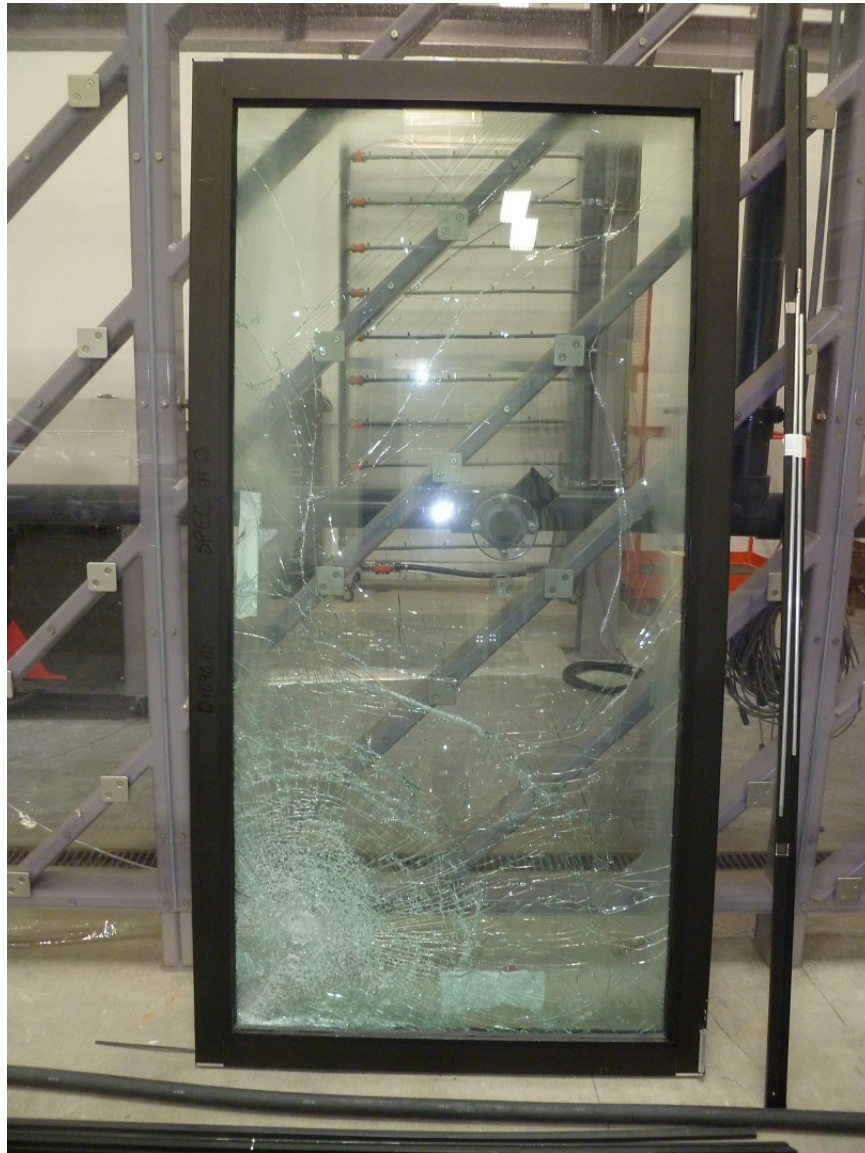
Photo No. 2
Impact Specimen #2

Impact #1: Missile Velocity: 15.4 m/s (50.4 fps)	
Impact Area:	Lower left corner of panel without hinge at jamb
Observations:	Missile hit target area, no penetration or tearing.
Results:	Pass

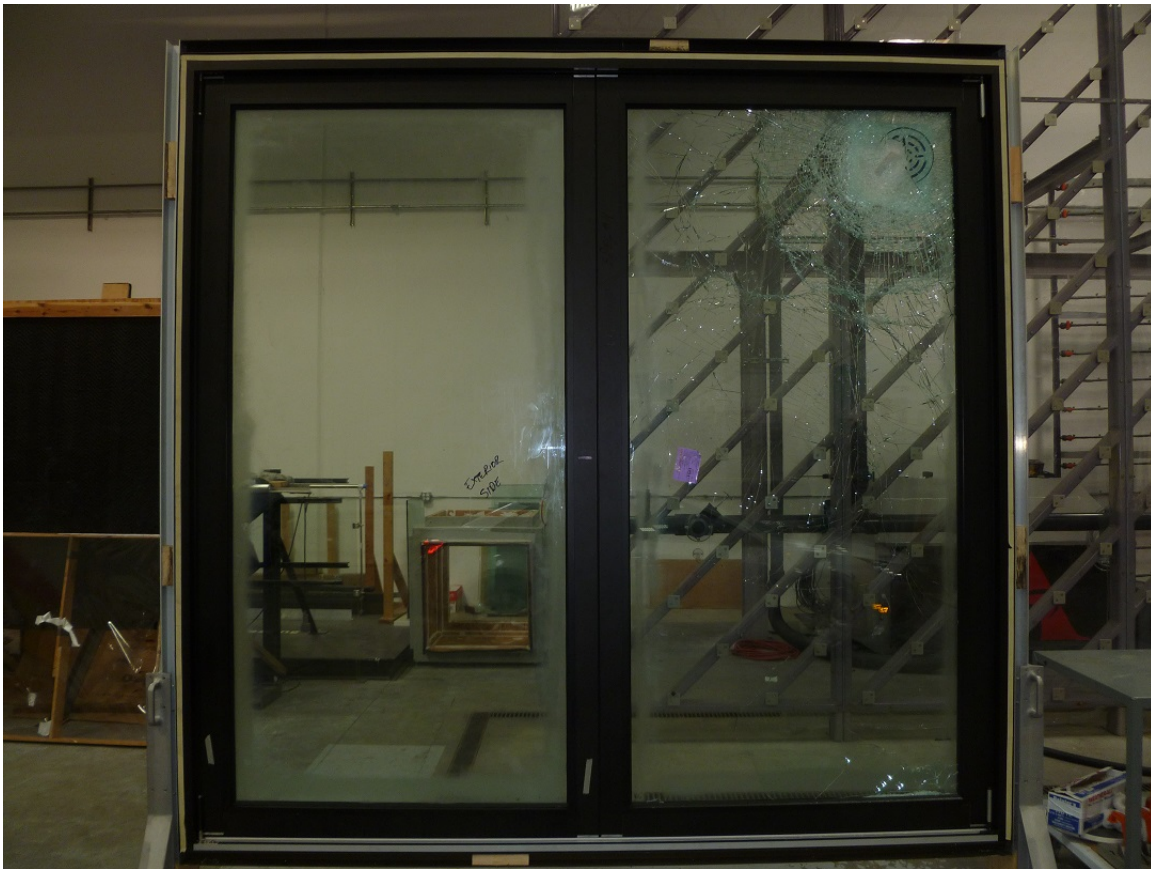
Photo No. 3.
Impact Specimen #3

Impact #1: Missile Velocity: 15.5 m/s (50.9 fps)	
Impact Area:	Top right corner of panel without hinge at jamb
Observations:	Missile hit target area, 1.5"x3.5" rectangular tear, 3" diameter solid sphere not able to pass through opening.
Results:	Pass

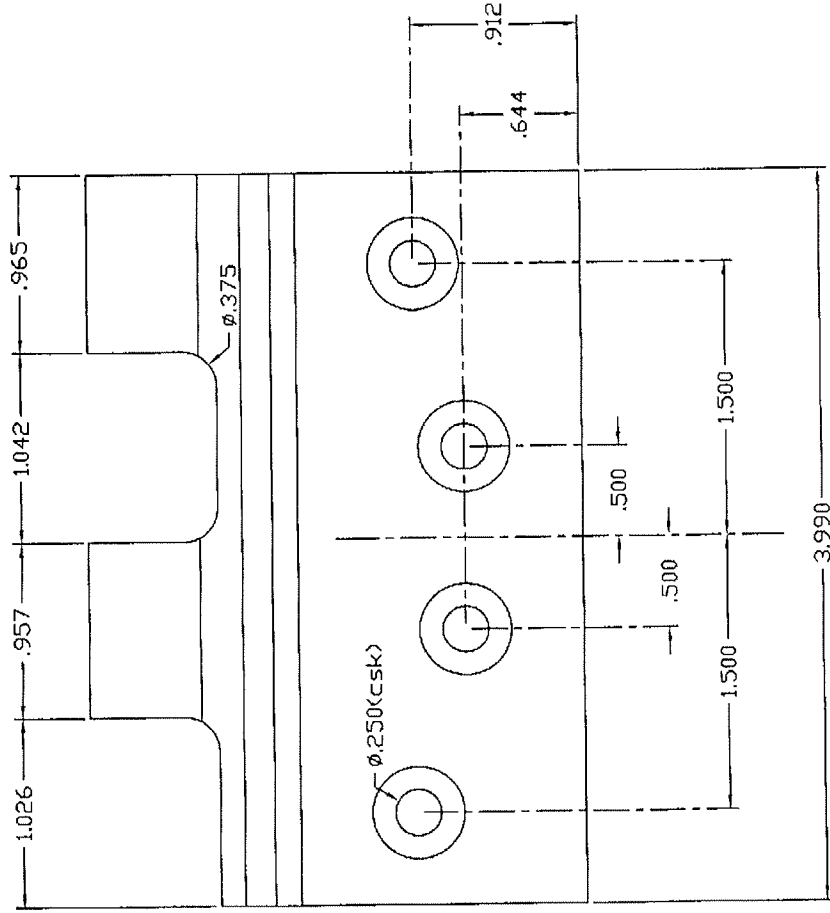
BF-62-F01

Material: aluminum
clear or black anodize
hinge half

Description	Quantity	Location
Hinge, Part #BF-63-F01	4	1/2" from top and bottom of the panel jamb stile.
Hinge, Part #BF-62-F02	3	1/2" from the top and bottom of the vertical stile between panels, midspan of the vertical stile between panels.
Hinge, Part #BF-62-F01	3	Directly opposite of Hinge Part #BF-62-F02
Hinge pin & handle assembly, Part #BFH-07	1	Located midspan of the vertical stile between panels in the hinge.
Lock rods, Part# 777-03-F01	2	Located at the center hinge stile of the active panel.
Intermediate hinge pin, Part #BFH-05	2	Located at the head and sill of the vertical stile between panels in the hinge assemblies.
Bottom sill jamb pivot, Part #BFH-03	1	Located at the sill corner of the fixed jamb panel on the exterior face of the panel stile.
Top jamb starter pivot, Part #BFH-01	1	Located at the head corner of the fixed jamb panel directly above Part #BFH-03 on the exterior face of the panel stile.

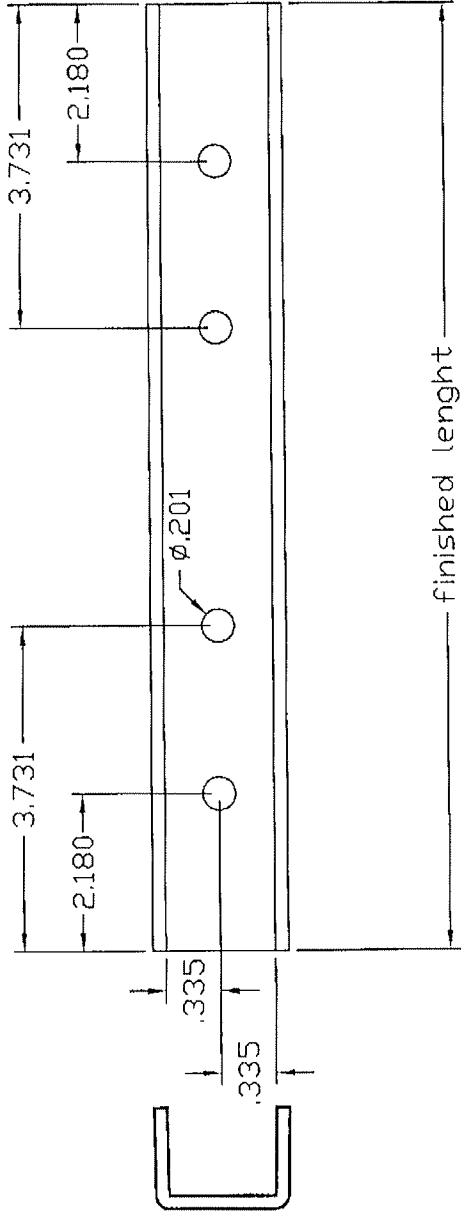
999VY-11-F03

Material: black PVC

sill guide track

Frame Member	Material	Description
Sill	Polyvinyl Chloride	Clip in roller track guide track, Part #999VY-11-F03
Jambs	Aluminum	Thermally broken extrusion, Part #BF-04

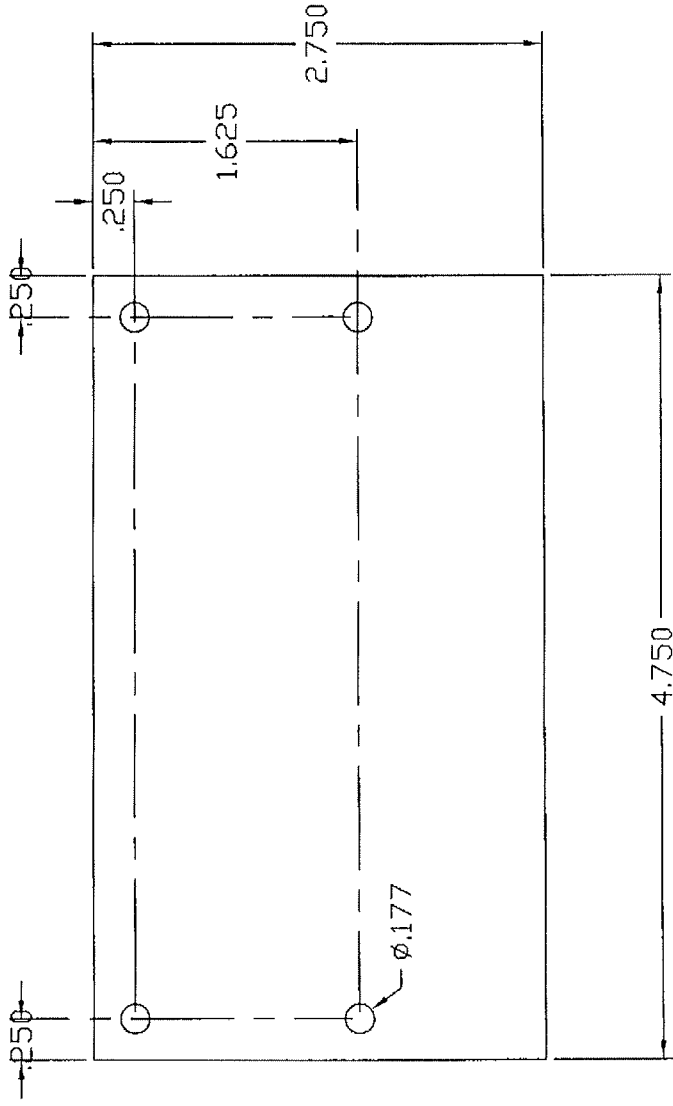
777-02-F01

Material: mill finish aluminum

head track end dam

Frame Member	Material	Description
Head	Aluminum	Thermally broken extrusion, Part #BF-01
Head	Aluminum	Head track end damn plate, Part #777-02-F01
Sill	Aluminum	Thermally broken extrusion, Part #BF-03
Sill	Aluminum	Clip in bottom roller track insert, Part #BF-03C-F03

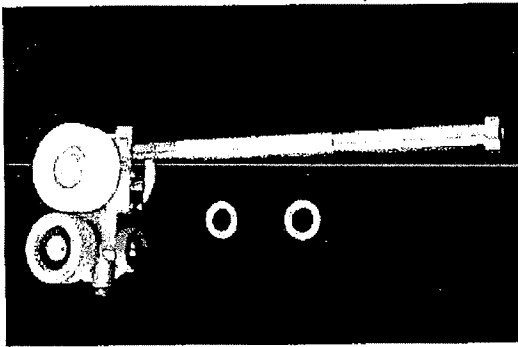
BFH-08 Half roller assembly

Half sill guide assembly, Part #BFH-09	1	Located at the sill corner of the active jamb panel on the exterior face of the panel stile.
Half roller assembly, Part #BFH-08	1	Located at the head corner of the active jamb panel directly above Part BFH-09 on the exterior face of the panel stile.
